HERACLES NEWSLETTER

N°4 - June 2017

HERACLES

HERitage Resilience Against CLimate Events on Site

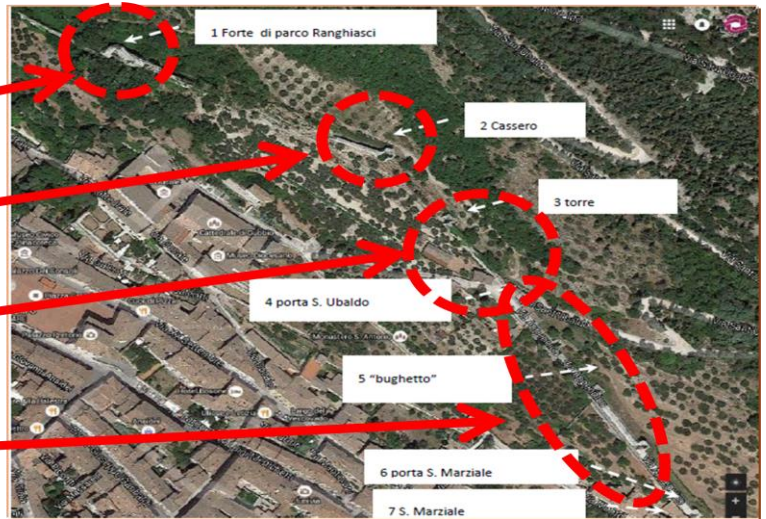
Figure 8 - test beds areas

- i. Zone 1 (“Forte di Parco Ranghiasi”);
- ii. Zone 2 (“Cassero”);
- iii. Between zone 3 (“Torre”) and zone 4 (“Porta S. Ubaldo”)
- iv. Between zone 4 and zone 5 (“Bughetto”)

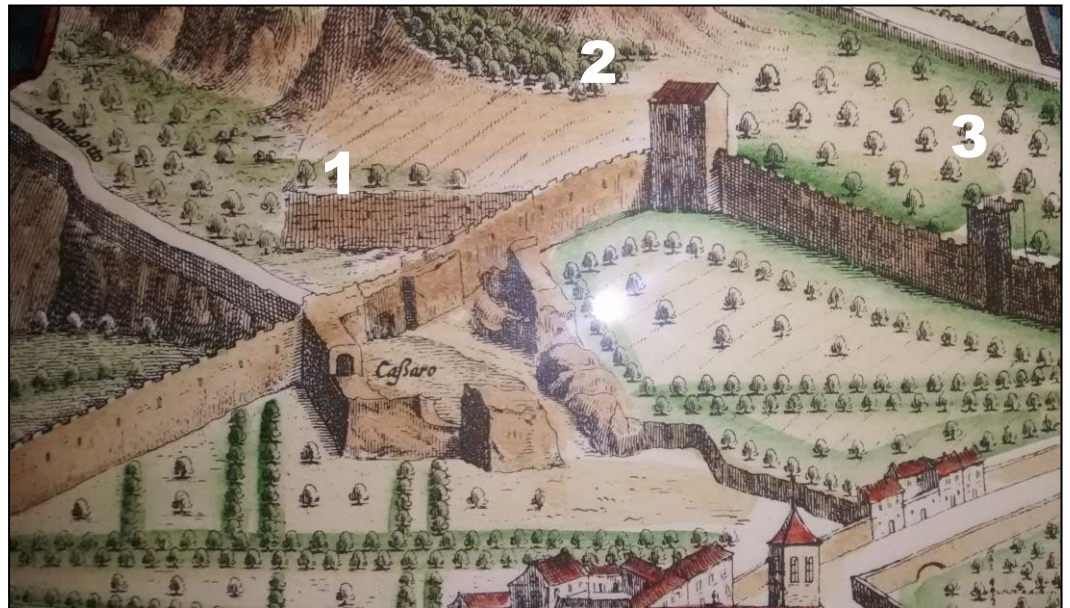
Figure 9 - Test bed sites zones 1 -2 -3 (J.Blaeu 1663)

The map draw by J. Blaeu in image 9 above, shows how the "2 zone - Cassero" building looked like then (as it is today named popularly but erroneously). The appearance of that tower looked like a 3-storey structure, also closed towards the valley (now partly demolished).

The Zone 1 (“Forte di Parco Ranghiasi”) as seen above was built in the Umbrian period, more than 2500 years ago, and then due to the last city expansion, completed in 1301. The walls protected the “Cassero”, a fortification built nearby, close to an ancient gate (“S. Agnese” according to Micalizzi) that led to the gorge of Bottaccione through probably an ancient Umbrian road whose remains can be seen few meters downstream of the middle age aqueduct. The gate was named after the monastery of S. Agnese and was built upstream

and was built upstream and outside the walls. It was demolished to build the Rocks of Mount Ingino at the end of Middle Ages. The “Cassero” was built during Middle Age, modified several times, mostly between 1376 - 1386 and 1413-1414 by Mastro Agnolo da Como during Montefeltro’s domination, when it became definitively part of the defensive system of the city. In the 19th century due to the building of Marquise Ranghiasi-Brancaloni’s park, the “Cassero”, already damaged, was demolished and the gate disappeared. There are today a few ruins and ancient maps and engravings to witness their presence.

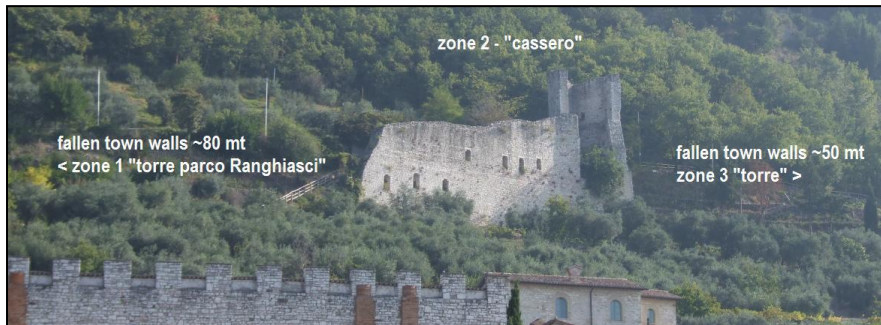
Figure 10 - fallen walls (after XVIII century)

During the last 8-10 centuries, several meters of soil accumulated against the walls. The situation was only partially mitigated in zone 1 by the historic aqueduct, which had also the function of a retaining Walls, too. At present, the estimated soil accumulation, insisting on the Walls, is more than

5/6 metres, so it has been increasing with a rate of around 50 cm / century.

As risk mitigation action, the water flew out through the Walls and the drainage of the gravel soil were ensured by means of on-purpose designed holes/channels in the structure. However, the ground material obstructed the channels. This caused the increase of the groundwater level and consequently the risk of the structural instability of the Walls. Currently there are no major landslides in place, but collapses of the Walls occurred over the last centuries. Just upstream this building was made a restoration over thirty years ago, removing the soil accumulated upstream of the walls and pushing on them. A 6 metres concrete retaining wall was built, with post-tensioned cables placed far ~4 metres from the ancient structures and finally reshaping the slope uphill. The walls in zone 3, however, have not been subjected to interventions in the recent past, so that the main danger is represented by the build-ups of moving terrain that can reach several meters of altitude.

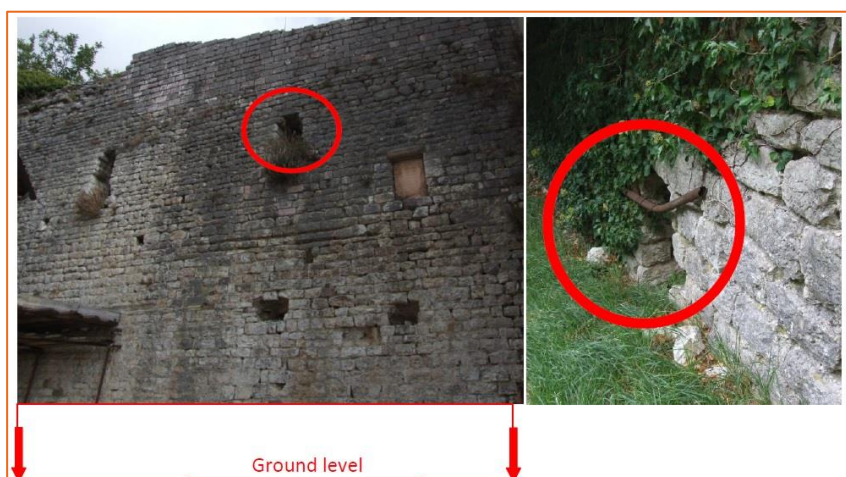
Figure 11 - zone 3-4: Walls downstream side (on the left) and upstream (on the right) - notice the opening at around 6 metres from the ground level downstream and the same opening at ground level on the right.

The opening is indicated by a red circle. The downstream ground level is indicated by a red arrow.

As well, in following images, the same opening on the walls is shown, as it appears from the two different Walls sides (upstream and downstream). It is possible to see the great difference in height with respect to the ground level, upstream and downstream. Upstream, the opening results at ground level, meanwhile downstream, it is at an height of almost 6 meters from the ground level. It means that from the mountain side, at least 6 meters of soil are pushing on the Walls.

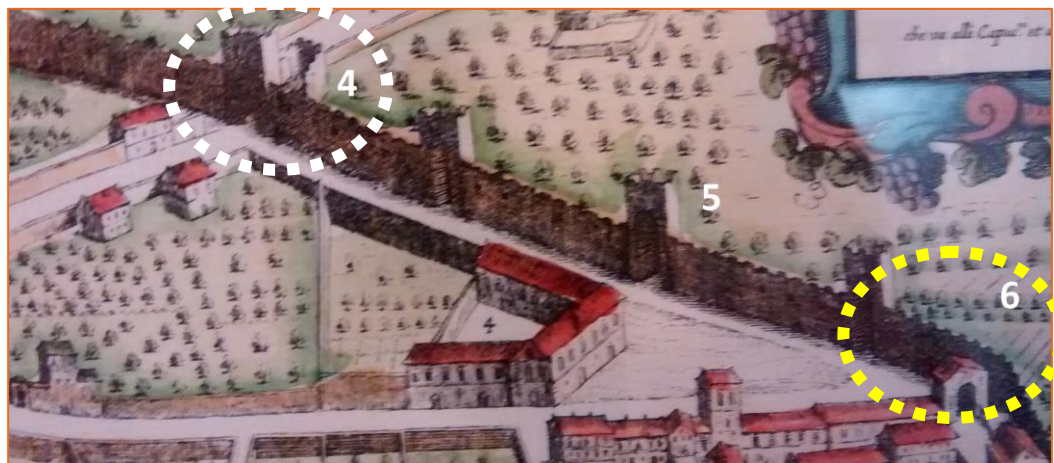
Figure 15 - Test bed sites 4 -5 -6 (J.Blaeu 1663)

The zone 4 is popularly named “porta S. Ubaldo”, since from it starts the road that leads up the mount to S. Ubaldo Basilica where the incorrupt body of the Saint watches over the city. It was built in 1301 and then named “Porta Sant’Angelo”. It had on its top a covered level and in external part a bastion surrounded by walls (figure 12) that,

according to 1663 map, were completely above the soil level. Since that time the bastion was partially demolished and the soil reached the level of ~1/1,2 meters below the town walls, that means ~8 meters above the road

downstream (Via Appennino). Two major interventions were made in this part of the Walls (zones 4-5-6). These interventions were aimed mainly to remove the thousands of cubic meters of soil carried there by rains, since it was intensifying the load on the Walls and increasing the aquifer water levels. The intervention was made 8-10 years ago and divided in two parts. The first one concerned the part of the Walls between S. Ubaldo and S. Girolamo doors for about 125 m. The soil slipped against the Walls over last centuries was removed and it was used to make rammed-earth wall or "retaining/reinforced earth wall" (about 3 metres upstream of, and parallel to the Walls); the hollows present in the collapsed areas were filled; the external facades were restored (eradication of plants, roots and weeds shrubs using pesticides, without affecting the existing binder; treatment with anti-mould and anti-moss; surface cleaning of the stones with low-pressure water cleaner; filling of the joints and cracks of the stones with mortar). Finally, a

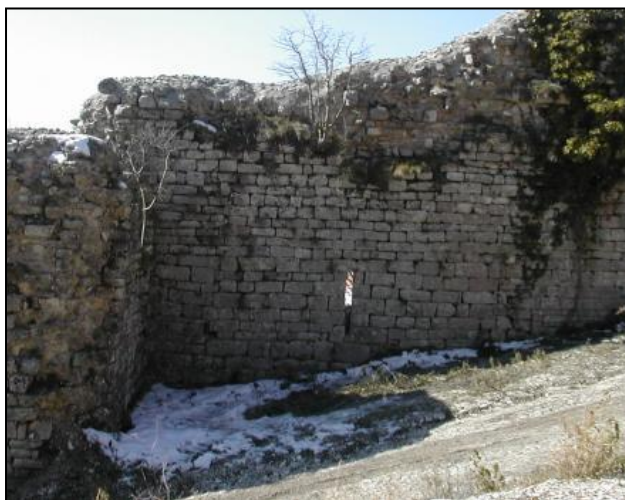
Figure 12 - zone 5: the slope before intervention

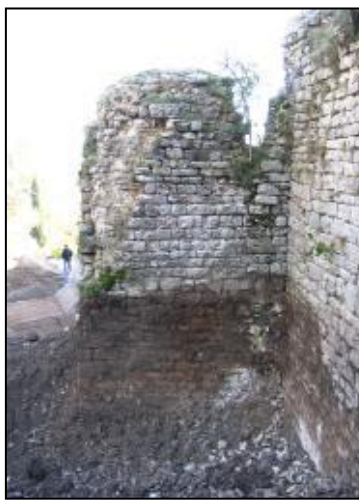
Figure 13 - during intervention

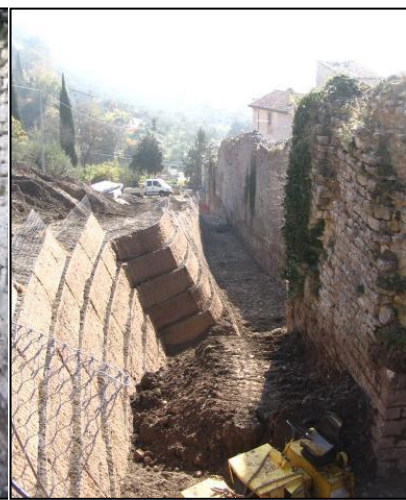
Figure 14 - after excavation during earth-retaining walls building

resin has been used to protect all the surfaces.

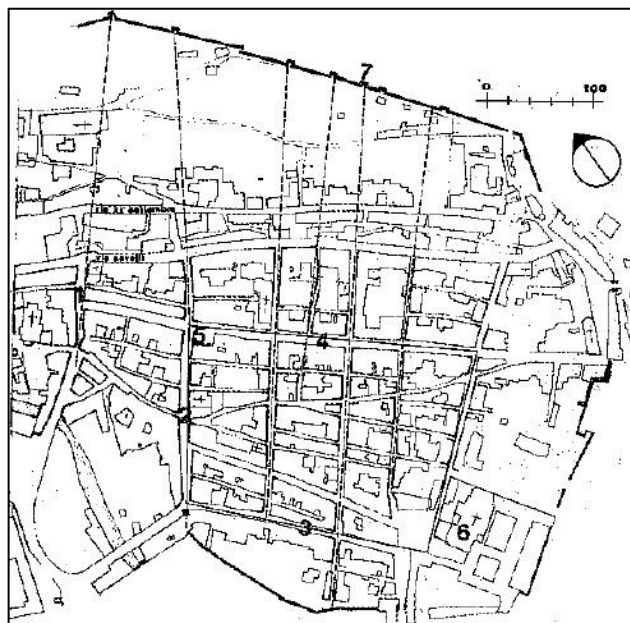
Figure 16 - alignments of the wall towers with main SW-NE roads

In zone 5 there are today 4 watch towers that interrupt the walls. The historian Micalizzi (1989) pointed out that these towers were built aligned with the main roads going upstream-downstream of the eastern part of the town, while a fifth tower (reported in ancient map by Ghelli) is today missing (probably destroyed).

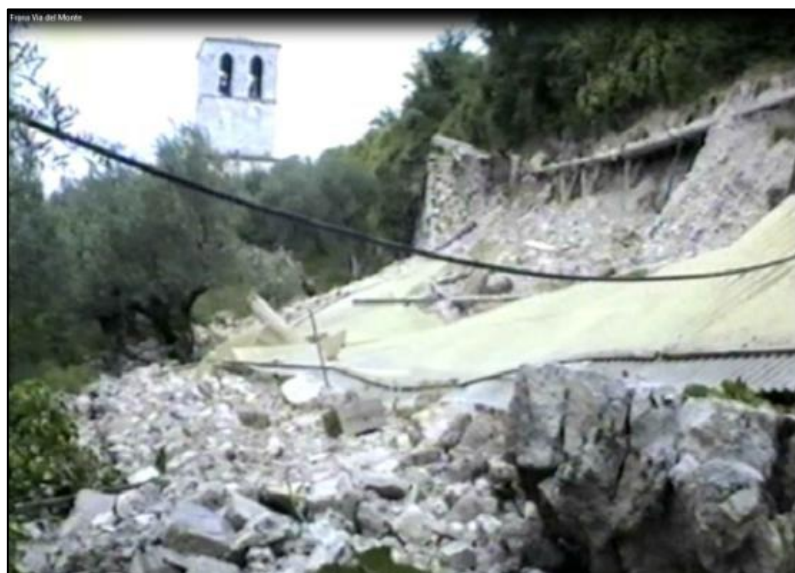
Figure 17 – ancient wall collapse in via del Monte

As specifically reported in the previous chapter, the Walls suffer mainly from torrential rains and humidity characterizing the soil surrounding the area and closely connected with the mountain natural area. The heavy rains increase the push on the Walls in two ways: the first one is through the washout producing and transporting rubbles, the second one through the increase of the aquifer level. All these conditions can adversely affect the statics of the Walls themselves.

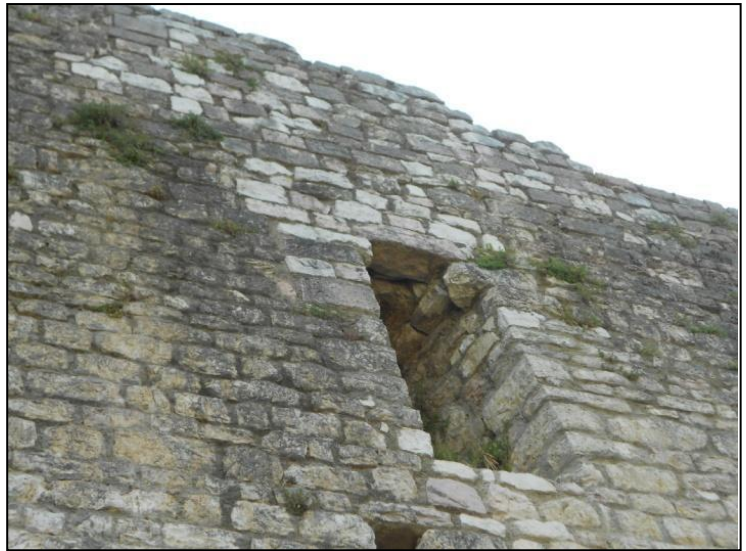
Figure 18 - dark patinas and differential blackenings

two different extraction periods. The oldest limestone was extracted prior to 15th century and does not exhibit significant criticalities. The second limestone type (extracted later) is affected from a significant degradation with the formation of dark patina (“Black crusts”) on the surfaces.

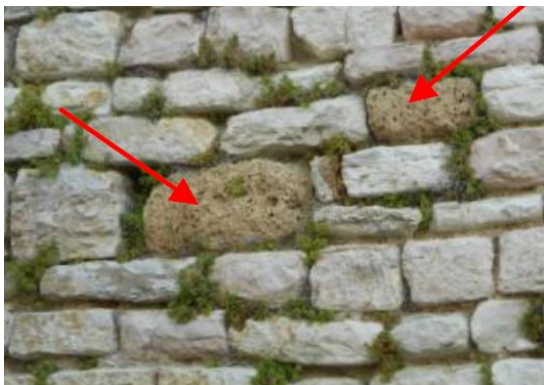
Figure 19 - Travertine stones

The presence of stones different from limestone such as travertine or sandstone can get the static equilibrium worse. Infact the city Walls were also built with waste materials from abandoned and ruined Roman palaces/villas of the Roman Urbe in the valley that were used as a quarry.

These porous stones deteriorate faster than those of limestone, so the Climate Change may further accelerate this phenomenon leading to structural instability.

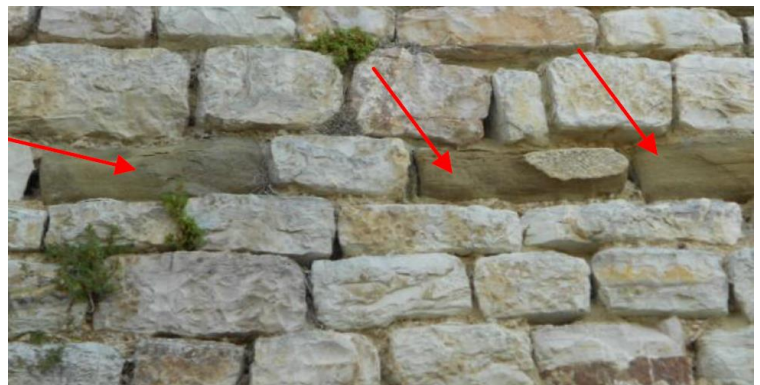
Figure 20 - sandstone bricks
